TECHNICAL REPORT M-286  
January 1981

CORROSION CONTROL OF PILINGS IN SEAWATER:  
BUZZARDS BAY

by  
A. Kumar  
R. Lampo  
A. Beitelman

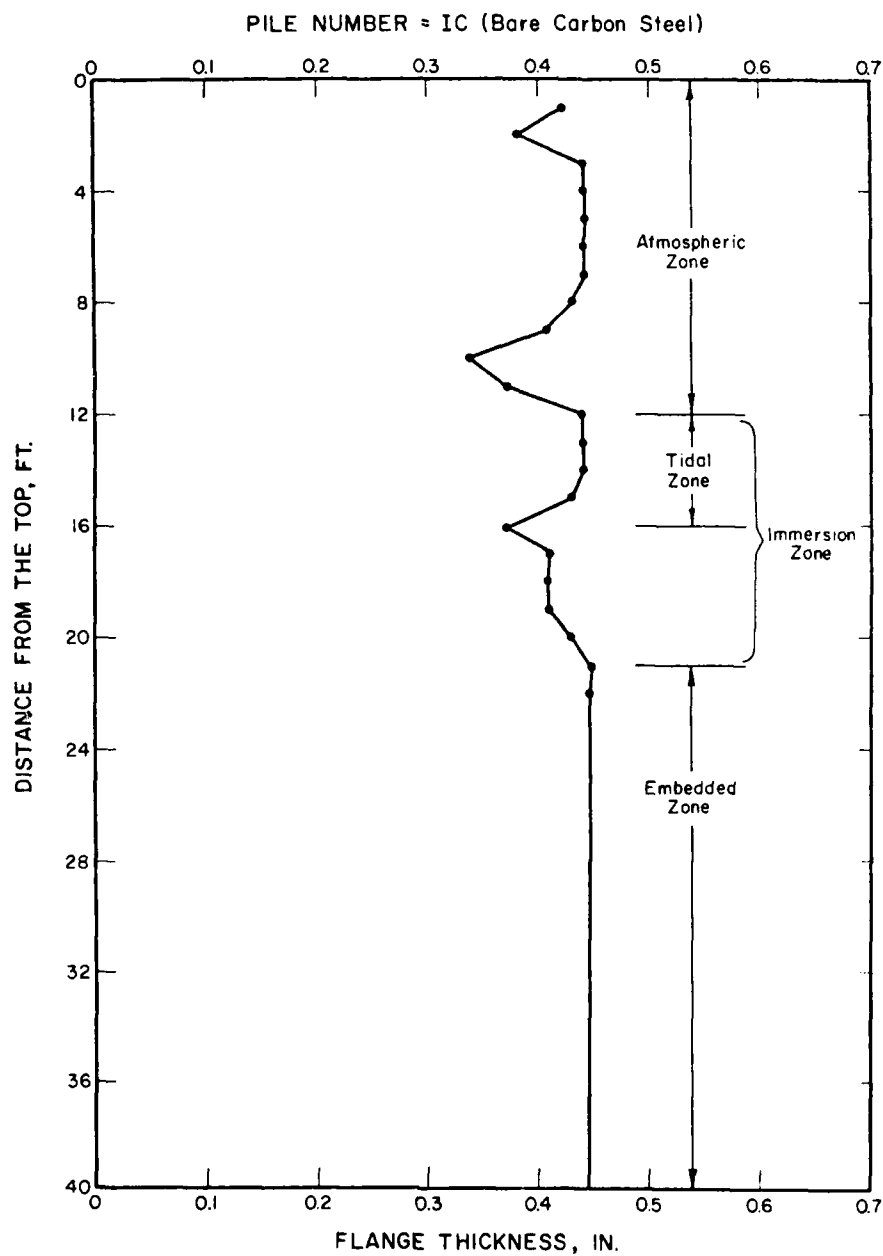
Figure 11. The flange thickness of bare carbon steel (ASTM A 36) pile at various depths.

The flange thicknesses of the bare and cathodically protected pilings are shown in Figures 10 to 15. It is observed that the average corrosion rate of bare carbon steel (A 36) in the immersed zone (excluding tidal zone) is 3.4 mils/yr. The corresponding average corrosion rate for bare Mariner steel (ASTM 690) in the immersed zone is 1.4 mils/yr. Sacrificial anodes reduced the corrosion rate to zero in the immersed zone.

1. Pile 1C was bare carbon steel and was corroding, but no pitting was noted. There appeared to be some delamination of the steel at the waterline.

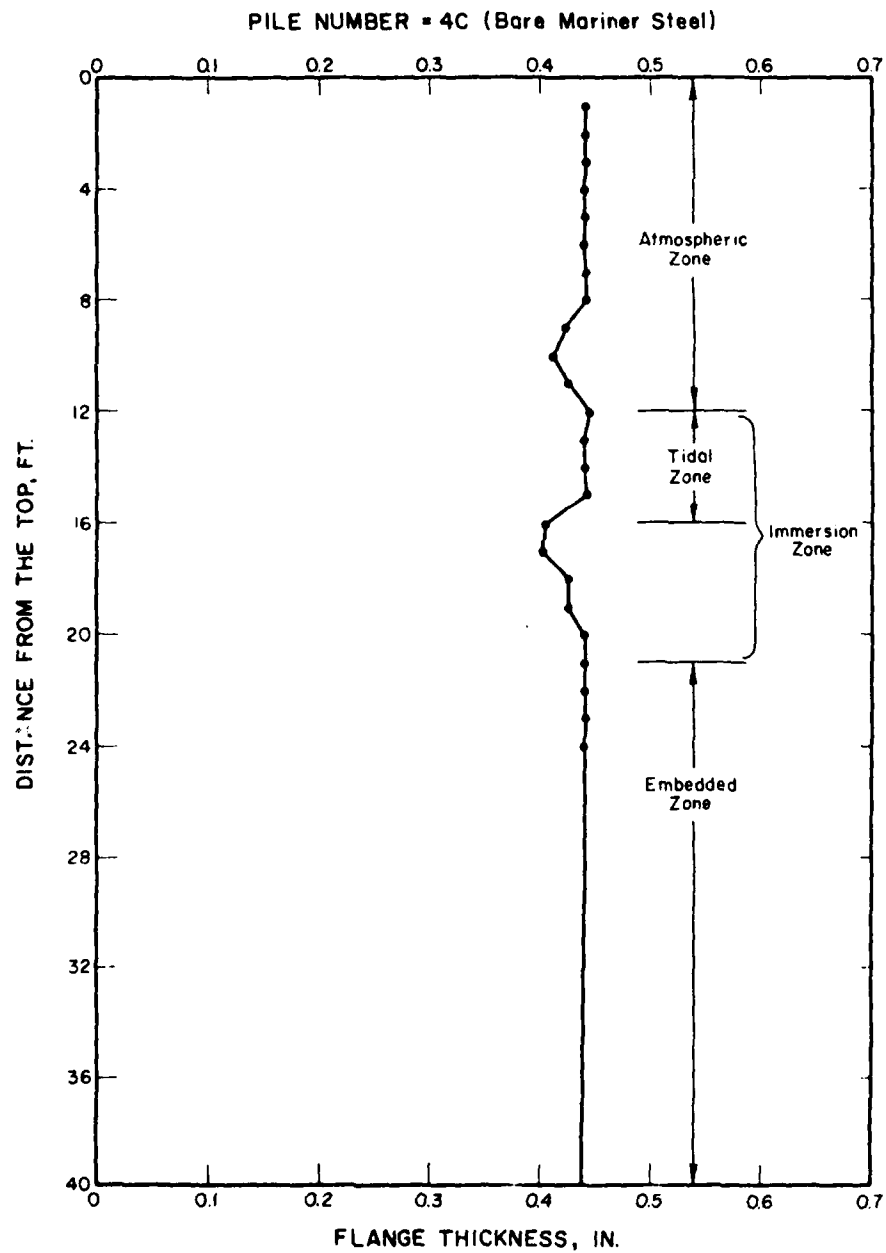
Figure 14. The flange thickness of bare Mariner steel (ASTM 690) pile at various depths.

1. Sacrificial anodes of zinc and aluminum effectively reduced the average corrosion of carbon steel (A 36) in the immersed zone from 3.4 mils/yr to zero. The average corrosion rate of Mariner steel (ASTM 690) in the immersed zone was 1.4 mils/yr.

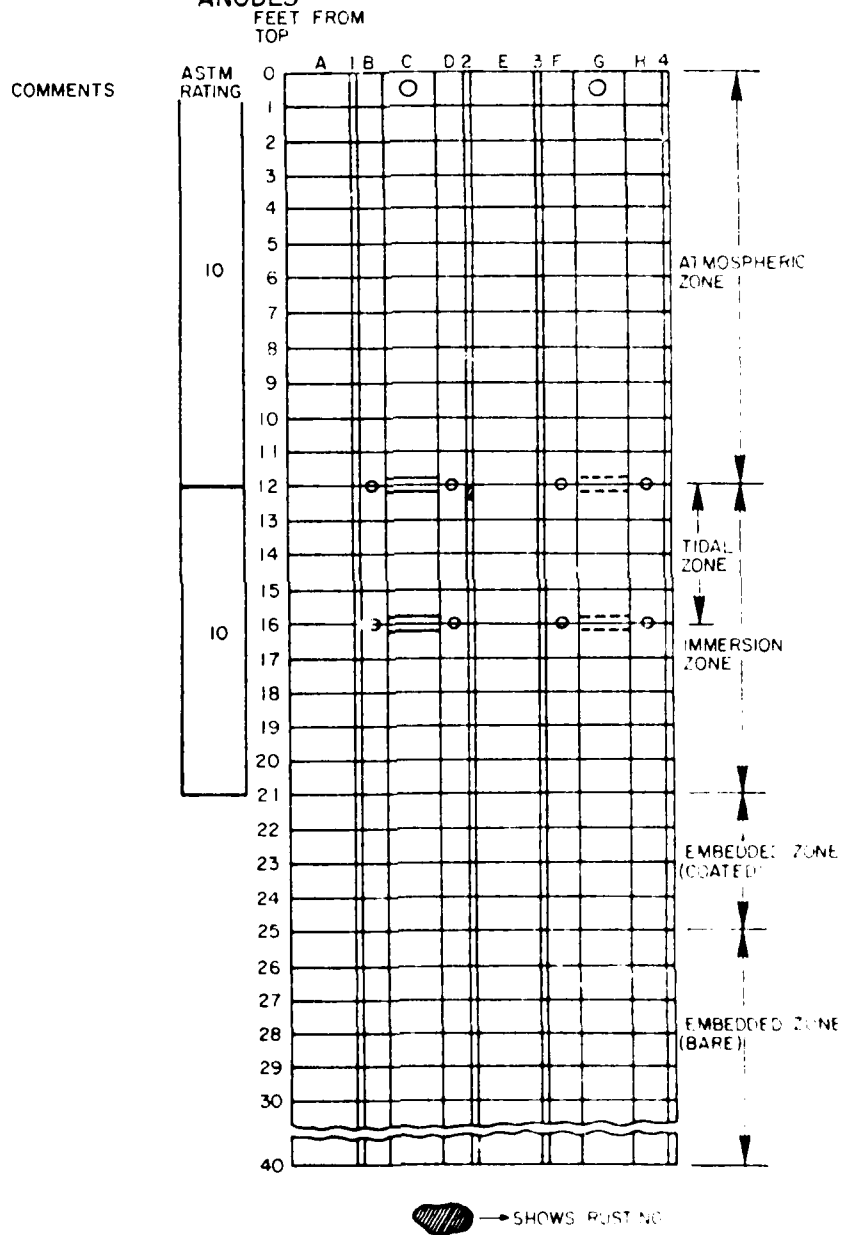
PILE NO 6C

2. Pile 6C had an epoxy, zinc-rich primer E-303 C-200 coal tar epoxy system with attached zinc anodes. The coating appeared to be in perfect condition, and the anode was in near-new condition. The coating thickness measured about 22 mils, with some measurements as high as 28 mils.

COATING: COAL TAR EPOXY OVER ZINC RICH WITH ZINC  
ANODES

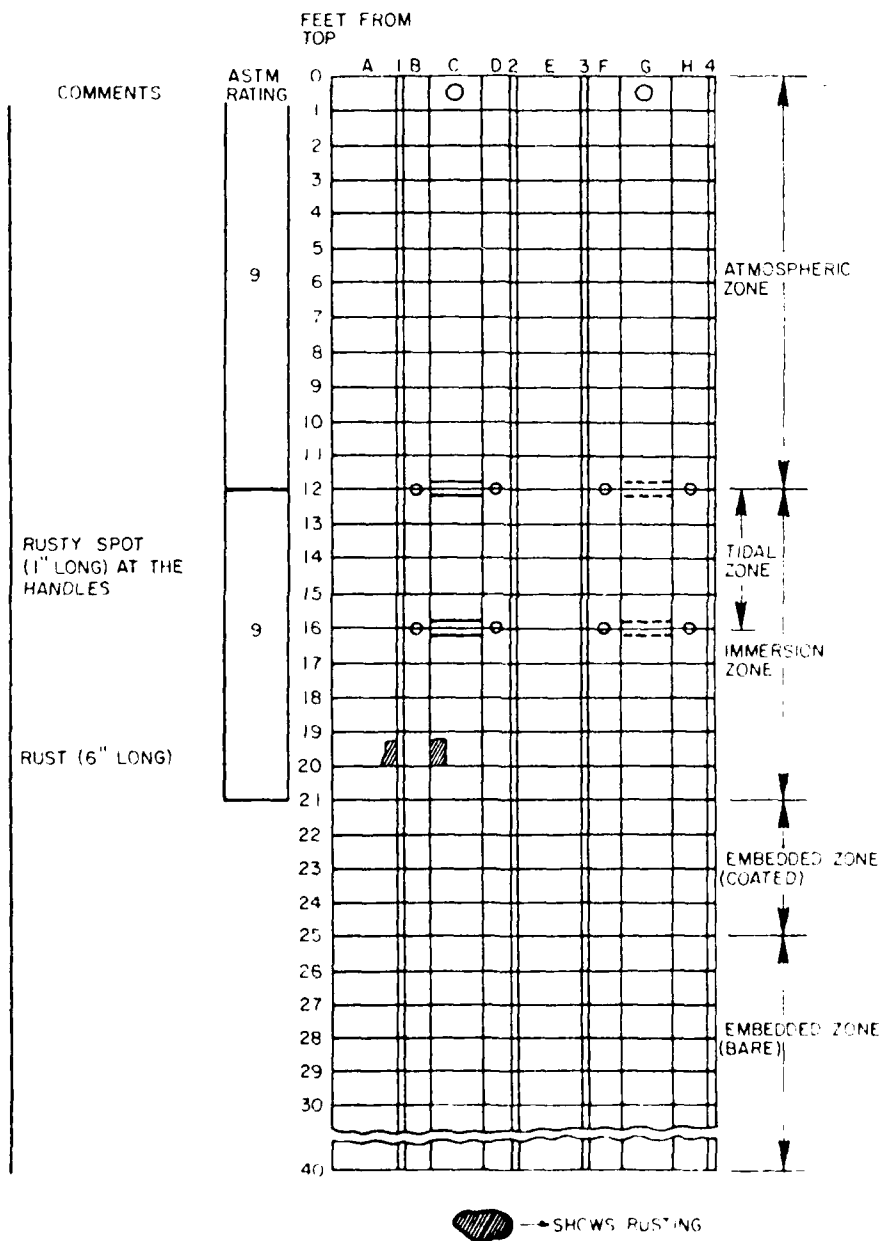
PILE NO 7C

3. Pile 7C had an epoxy, zinc-rich primer E-303 C-200 coal tar epoxy system with a coating thickness varying from 12 to 30 mils, with most thicknesses in the 20 to 30 mil range in the upper areas, and in the 16 to 18 mil range at the waterline. Several square inches of corrosion were noted at the waterline; where a handle had been welded to the pile. Poor surface preparation may have been responsible for the rust. In addition, the primer adhered poorly to the steel within about 1-1/2 in. (3.81 cm) of this corrosion. No other coating defects were noted.

COATING: COAL TAR EPOXY OVER ZINC RICH

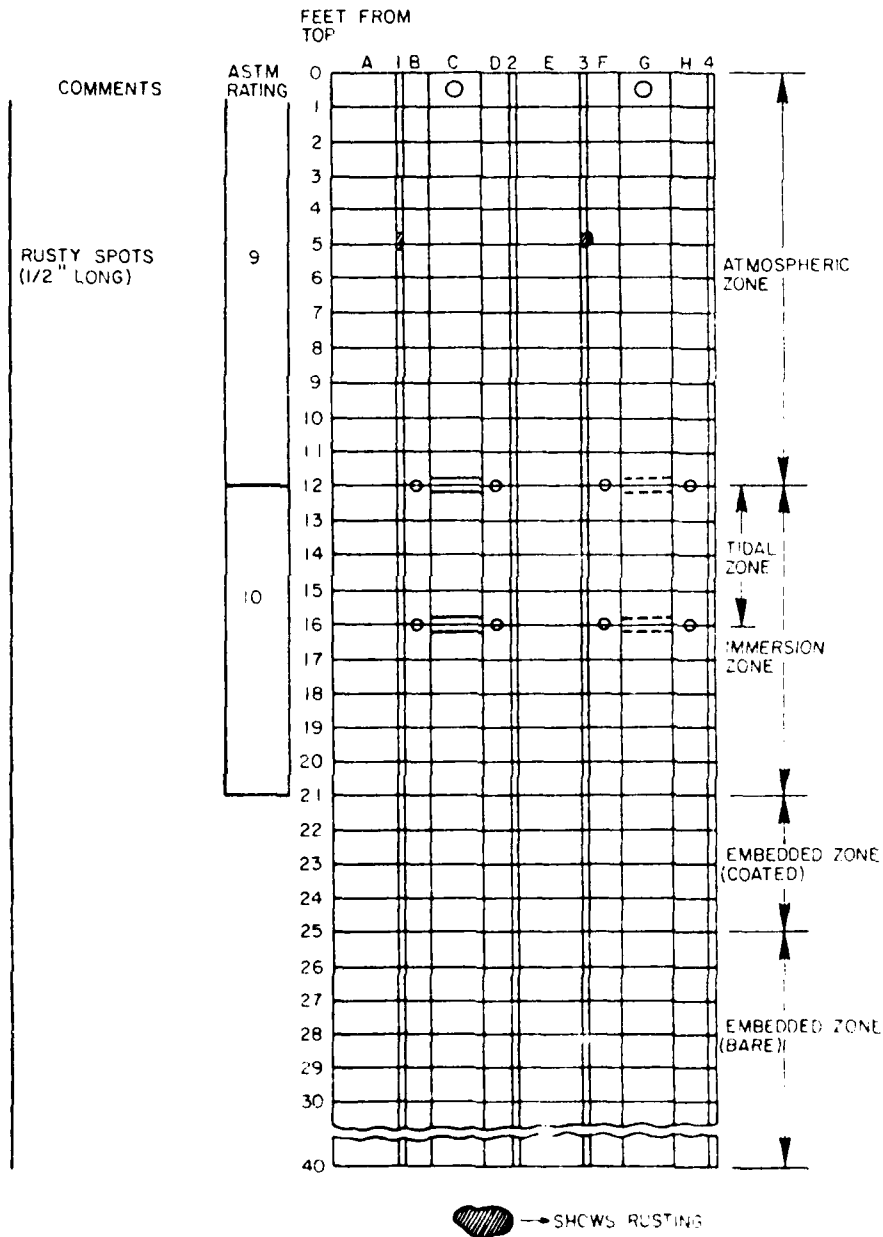
PILE NO 8C

4. Pile 8C had a Porter #352 Zinc Loc zinc-rich primer/C-200 coal tar epoxy system. Thickness was about 17 to 18 mils in the waterline area, with a few areas as thin as 13 mils. Other than damage done to the top of the pile by the driving operation, the coating appeared to be in perfect condition.

COATING: COAL TAR EPOXY OVER ZINC RICH

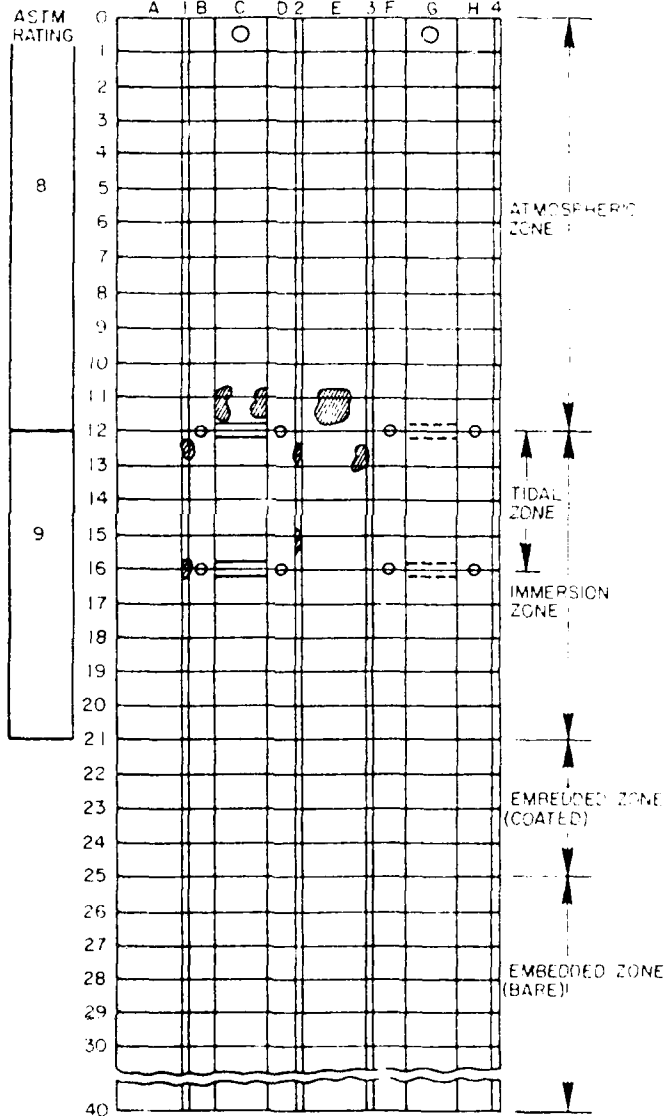
PILE NO 9C

5. Pile 9C was a zinc-rich primer E-303/C-200 coal tar epoxy system with aluminum oxide grit added to the final coat of C-200 coal tar epoxy. Thickness measurements were impractical due to the roughness of the coating system. The coating system was in excellent condition; however, the fouling was more abundant and more difficult to remove because of the system's roughness.

COATING: COAL TAR EPOXY OVER ZINC RICH, ALUMINUM  
ARMoured  
FEET FROM  
TOP

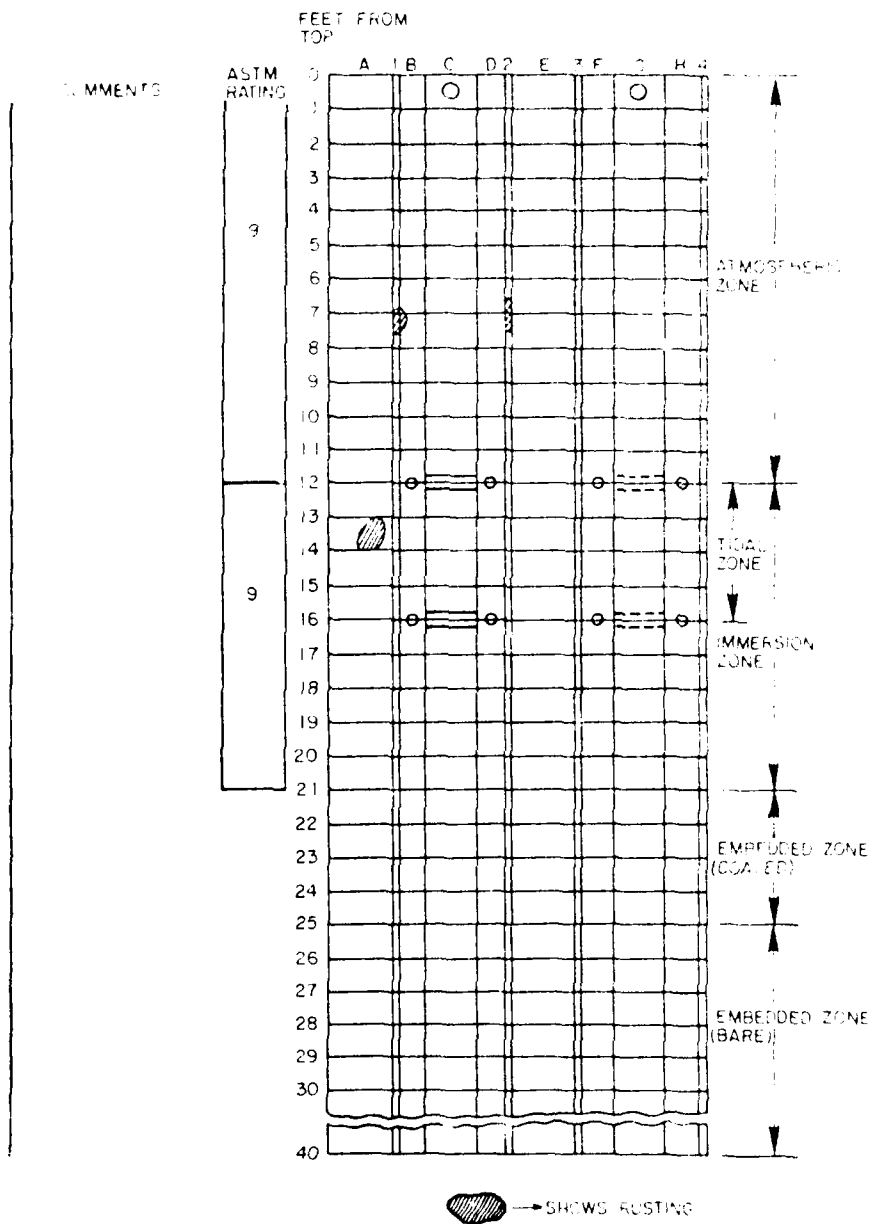
PILE NO 10C

6. Pile 10C had an epoxy resin primer manufactured by Porter, followed by a C-200 coal tar epoxy topcoat. Coating thickness at the waterline area was 19 to 25 mils, with some measurements as high as 30 mils. The system appeared to be in perfect condition.

COATING: COAL TAR EPOXY OVER EPOXY PRIMER

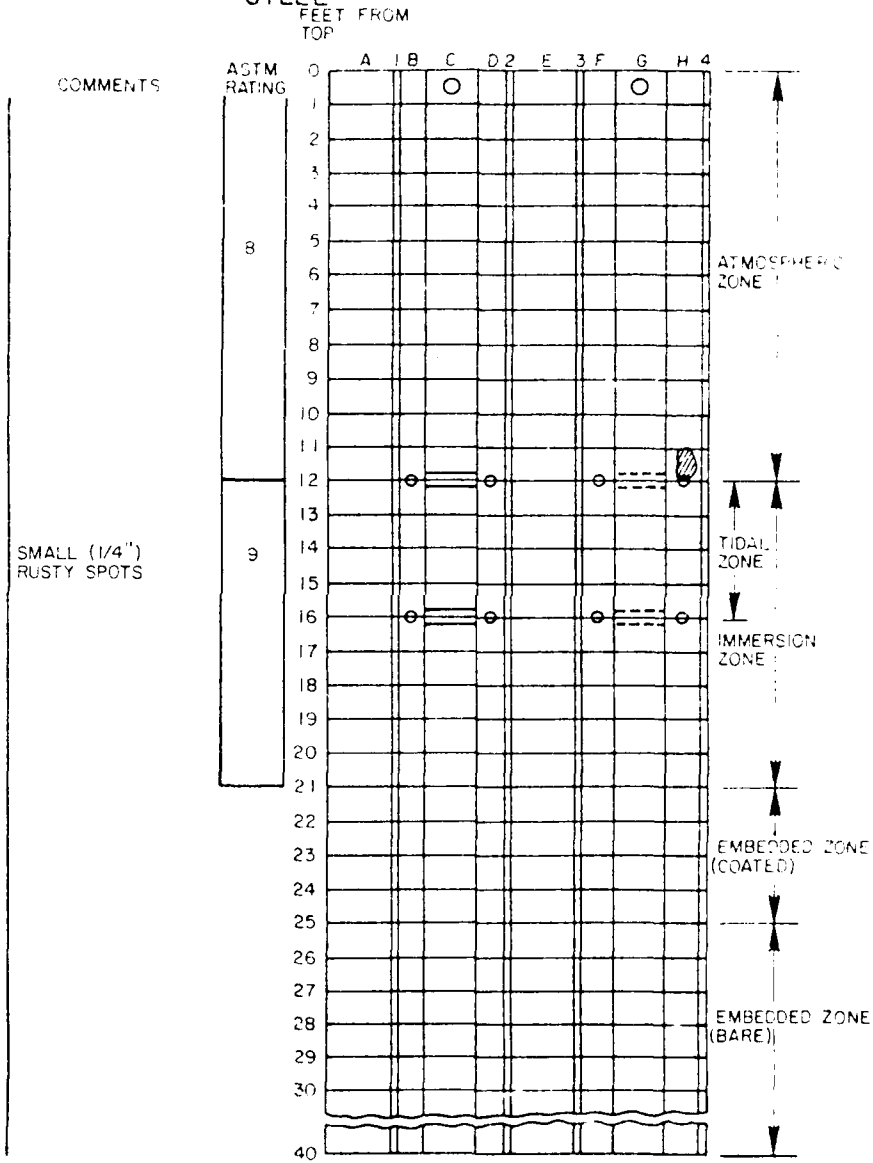
PILE NO 11C

7. Pile 11C was Mariner steel with zinc-rich primer F-303/C-200 coal tar epoxy system at a 20-mil thickness. The coating was in near-perfect condition.

COATING: COAL TAR EPOXY OVER ZINC RICH OVER MARINER  
STEEL

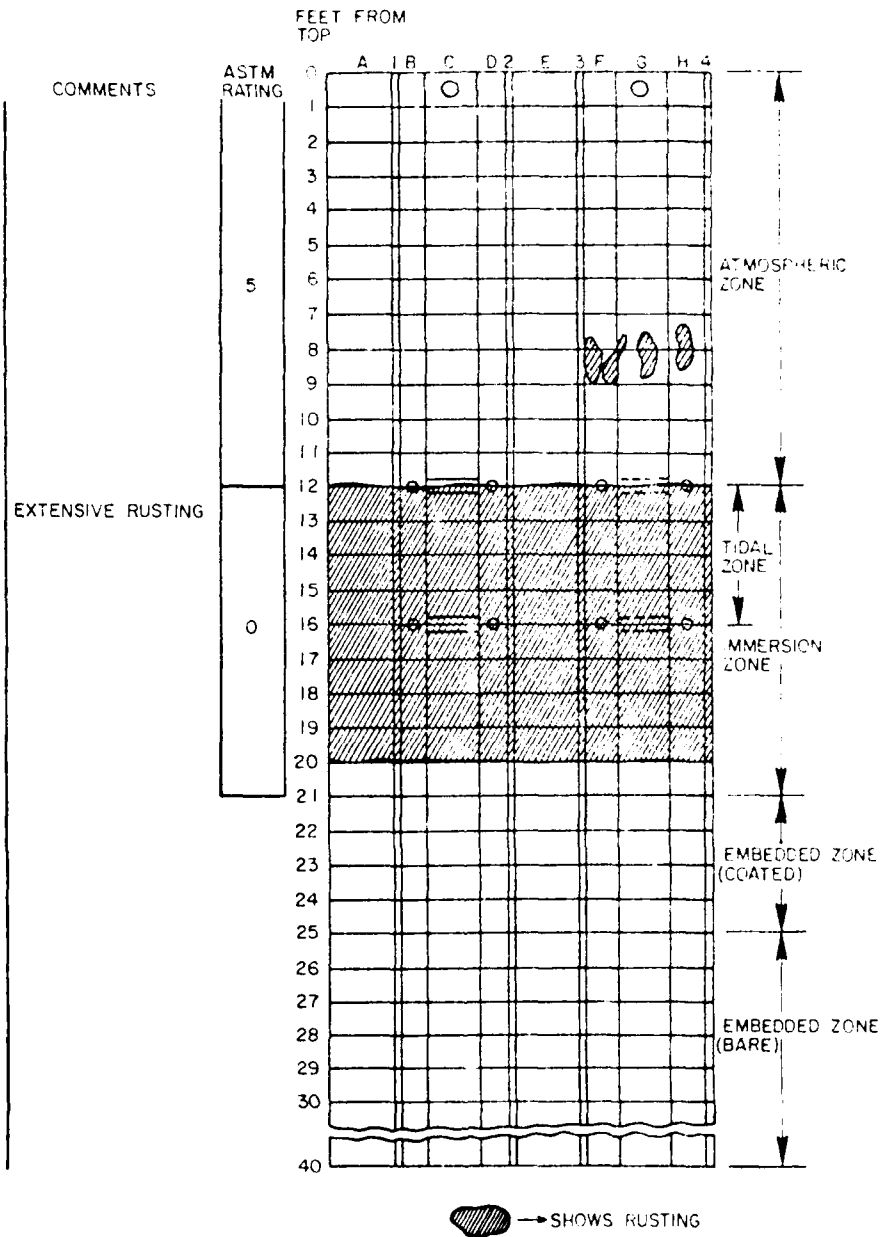
PILE NO 12C

8. Pile 12C was coated with a Plas Chem system consisting of a zinc-rich Zinc-ite primer, a ceramic Ceram-ite #101 intermediate coat, and a 2140Z high-build epoxy topcoat. The coating was extremely weak and had rust coming through. The system was nonexistent at the waterline, where there was heavy rusting. Coating adhesion was so poor underwater that it could be removed with the thumbnail. Thickness of the coating appeared to be about 10 mils above the waterline, and about 14 to 16 mils on underwater areas.

COATING: EPOXY OVER INORGANIC CERAMIC

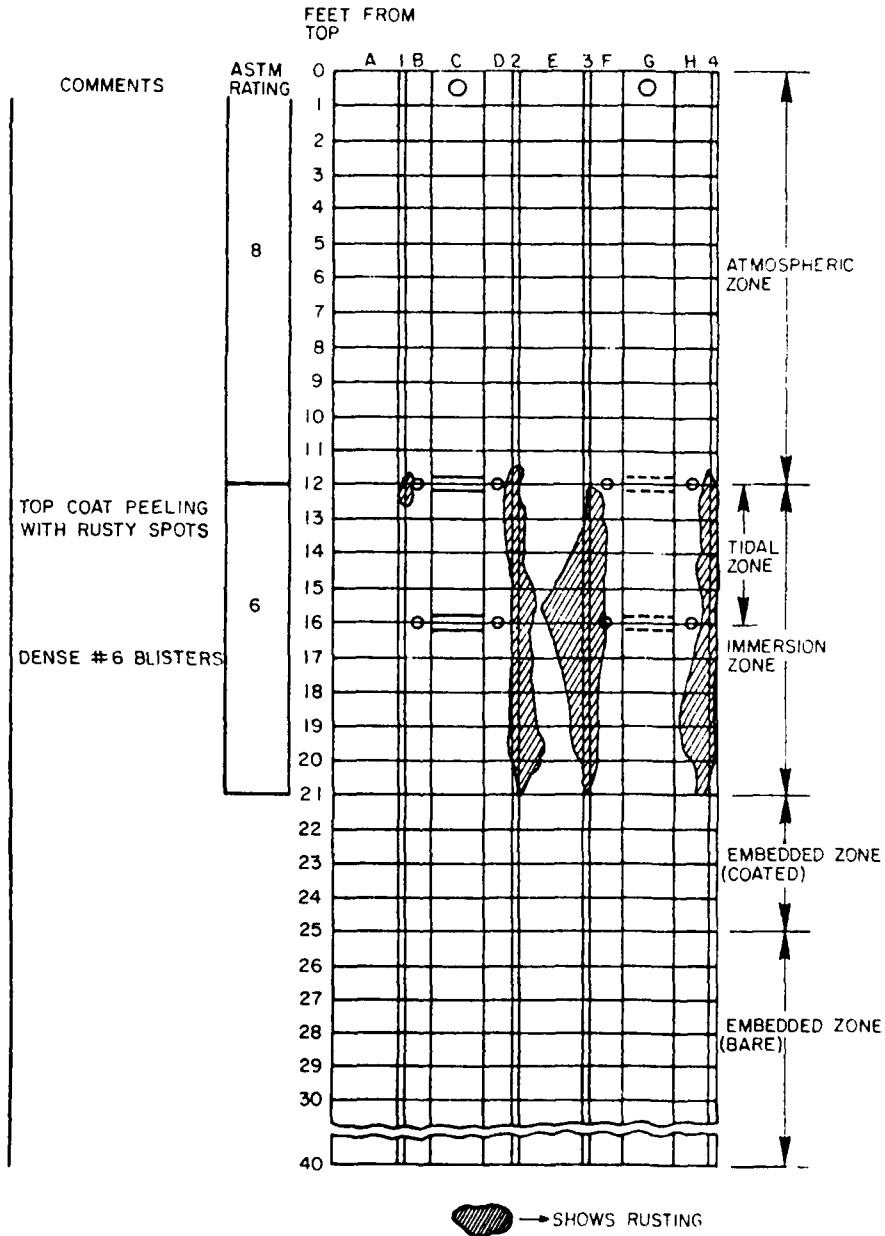
PILE NO 14C

10. Pile 14C had a Chemglaze organic zinc-rich primer with a Chemglaze II urethane topcoat, both made by Hughson Chemicals. The coating showed extensive rust along the edges in the atmospheric areas, and associated blistering and rust undercutting. At the waterline, some areas had no topcoat, while others had no coating at all. Extremely dense #5 and #6 blisters were present on underwater areas. The coating measured 5 to 9 mils, with much of the underwater areas measuring 6 to 7 mils.

COATING: POLYURETHANE OVER ORGANIC ZINC RICH

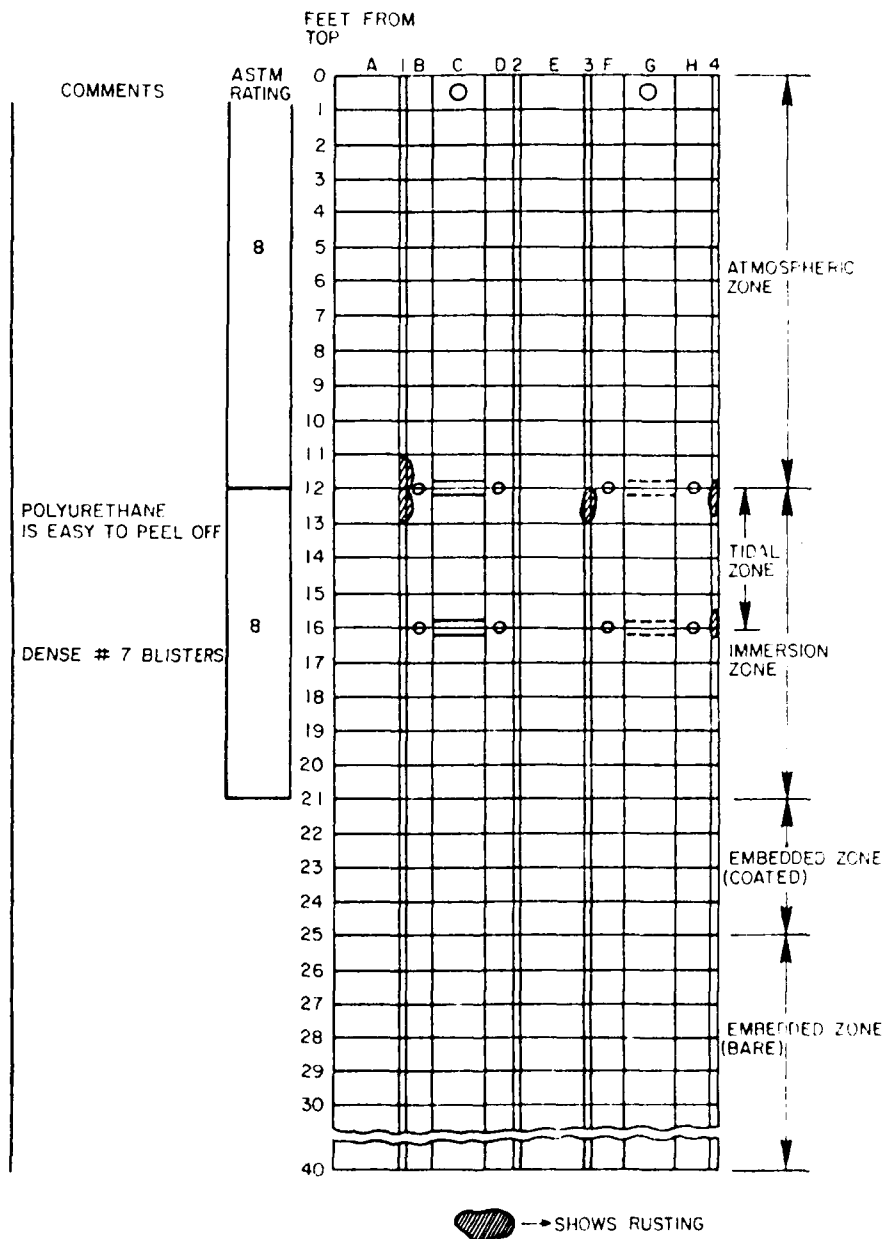
PILE NO 15C

11. Pile 15C had a urethane intermediate coat and topcoat over an organic zinc primer; all coatings were manufactured by Hughson Chemicals. Some corrosion broke through the coating on flat surfaces, and the sharp corners of the piles showed corrosion due to damage. Dense #6 and #7 blisters were noted along the damaged edges on underwater areas. Coating thickness measured 15 to 17 mils.

COATING: POLYURETHANE OVER ZINC RICH

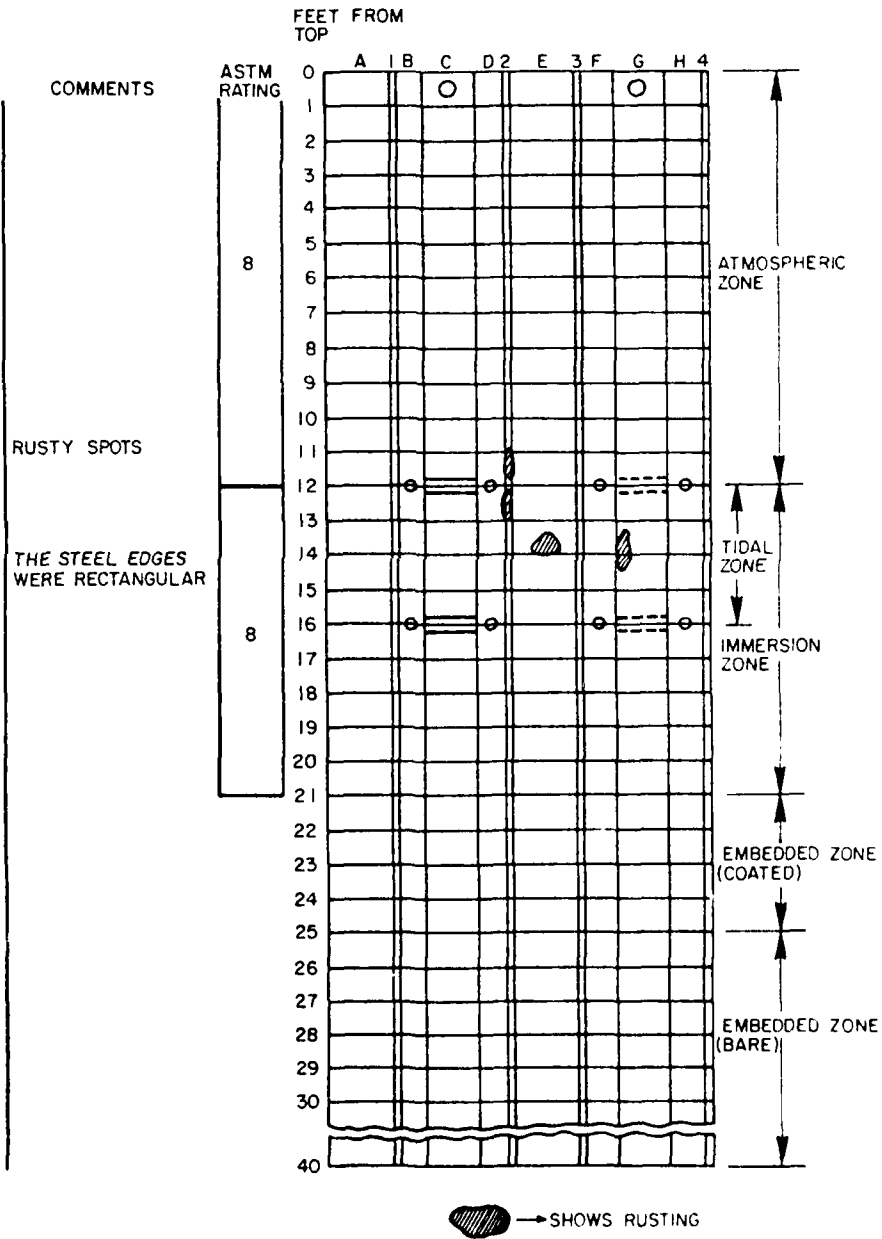
PILE NO 18C

14. Pile 18C had a flame-sprayed aluminum primer with a blue MIL-P-15328 wash primer and a Metcoseal Aluminum Vinyl Sealer. On the upper portion of the pile, there were 2- to 6-in. (5.08 to 15.24 cm)-wide lines of corrosion or blistering crossing the piling and spaced at about 2-ft (0.6m) intervals along the pile. These were probably caused by an application defect. Extensive blistering and the blue wash primer could be seen at many places along the waterline. However, the edges of the steel piling were still rectangular because of the galvanic cathodic protection.

COATING: FLAME SPRAYED ALUMINUM AND VINYL SEALER

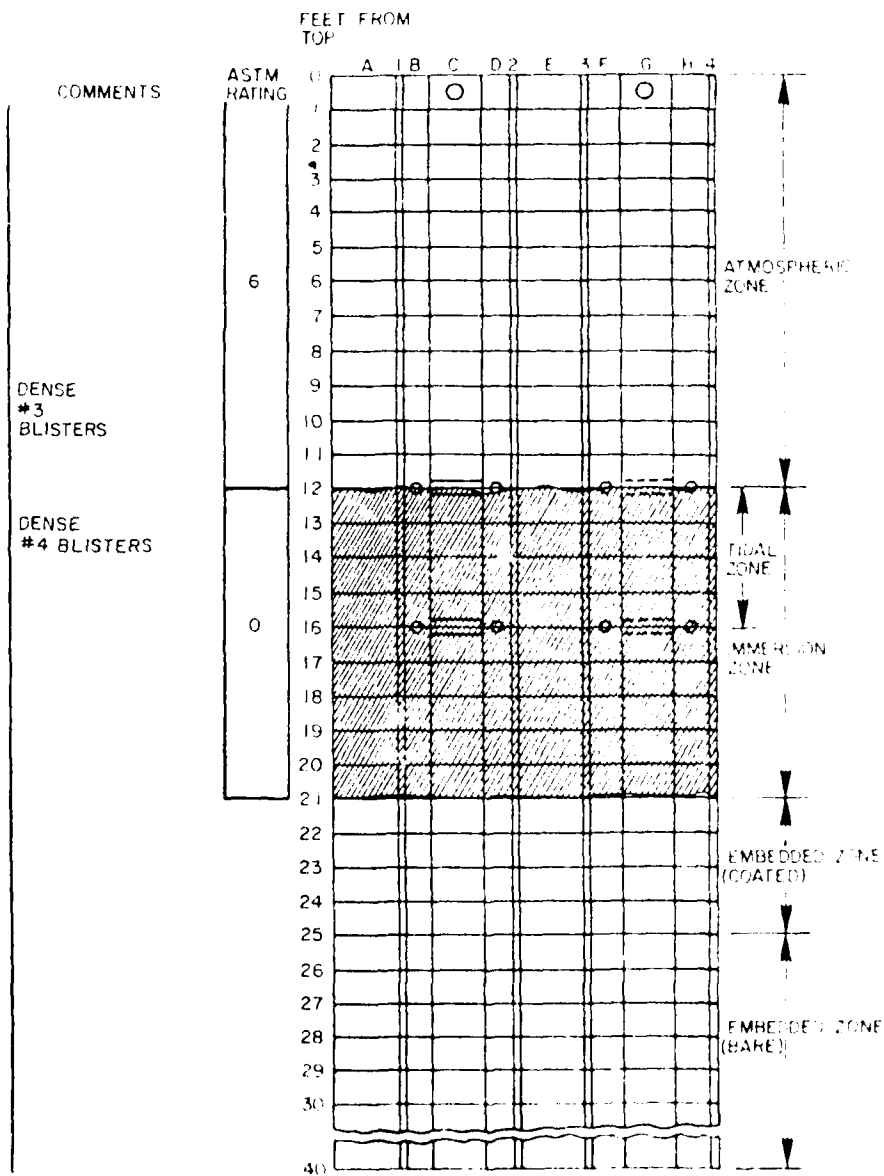
PILE NO 19C (PILE BENT BY ICE)

15. Pile 19C was primed with flame-sprayed zinc, coated with a coal-tar solution, and topcoated with a coal-tar emulsion. There were dense #4 blisters on all underwater areas, with extensive rusting in the splash zone. In the upper splash area, as much as 75 percent of the steel was bare and rusting. Atmospheric areas were in fair to poor condition, with minor rusting along some edges and extensive #4 blistering. The coating was extremely weak and crumbled when scratched with a jack-knife. Coating thickness above the waterline was 22 to 23 mils.

COATING: FLAME SPRAYED ZINC WITH COAL TAR EMULSION

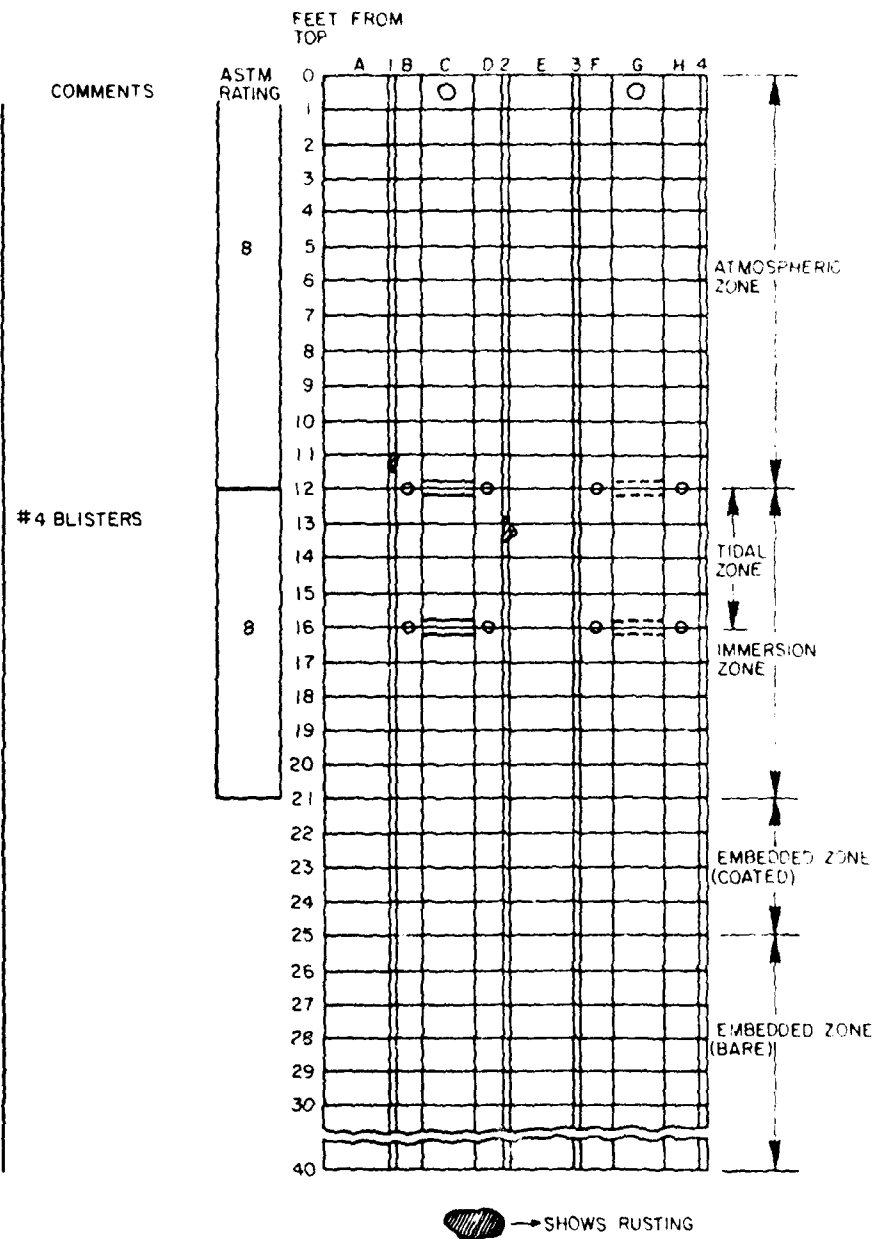
PILE NO 20C (PILE BENT BY ICE)

16. Pile 20C had a vinyl zinc with a vinyl glass flake VZ-108/V-110 vinyl paint system. The coating had dense #4 blisters on all underwater areas. There was almost no rust on underwater areas; however, some bare edges were rusting along the waterline. No rust undercutting was noted along the rusting edges.

COATING: VINYL GLASS FLAKE OVER VINYL ZINC RICH

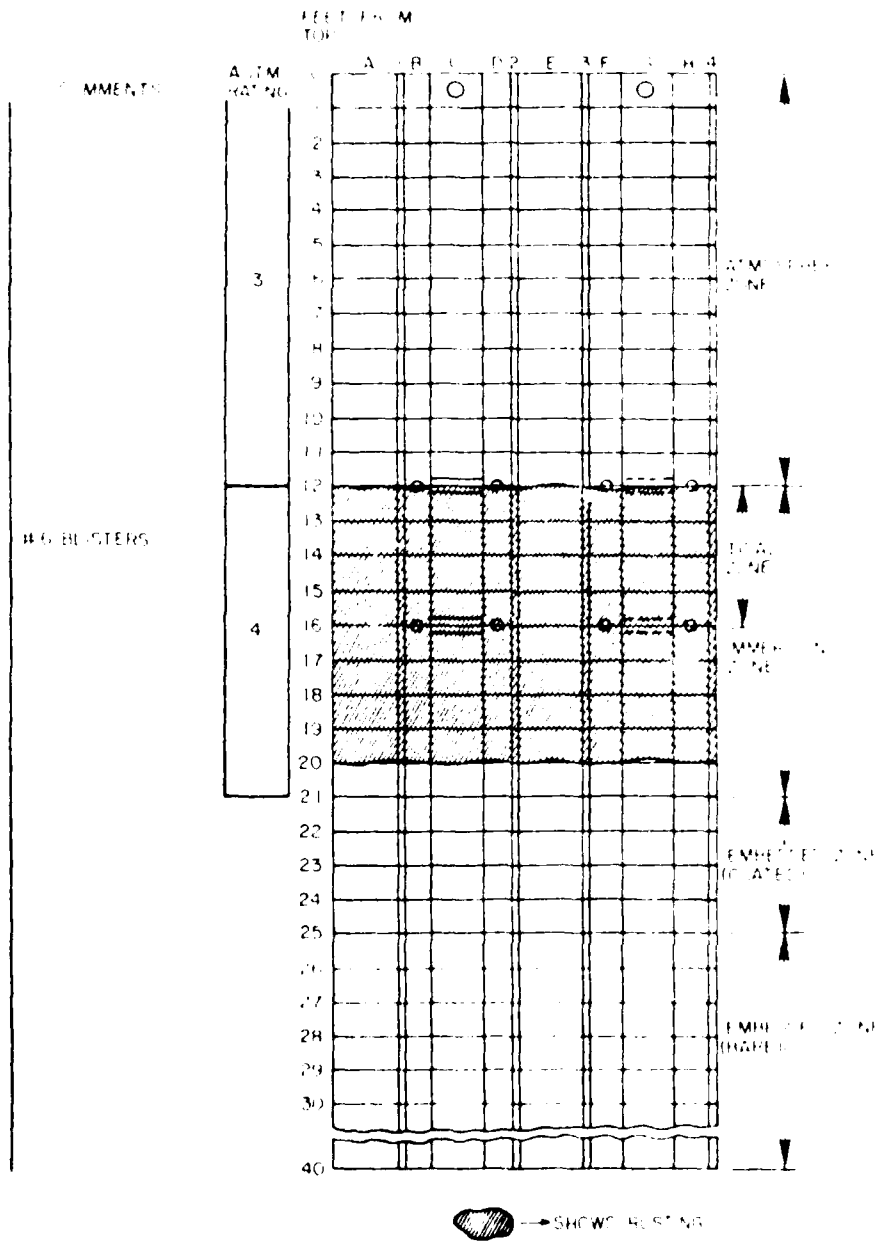
PILE NO 210

17. Pile 21C had an inorganic zinc Dimetcoat #3, a synthetic resin Amercoat #54 tiecoat, and a #87 vinyl mastic topcoat. The pile was bent sharply at ground level; the coating had shattered in that area, leaving the pile completely bare. There were medium-dense #6 blisters in the upper portion of the splash area. Some of the blisters were cracked and allowed the underlying steel to rust. Many of the edges of the pile were bare and rusting. Coating thickness measured about 9 to 10 mils.

COATING VINYL MASTIC OVER RESIN
